Manhole Inspection Summary

Manhole # S25II2007MH

Insp Date: **3/27/07 12:25 PM**

Location Address: **907 LAKE AVE**

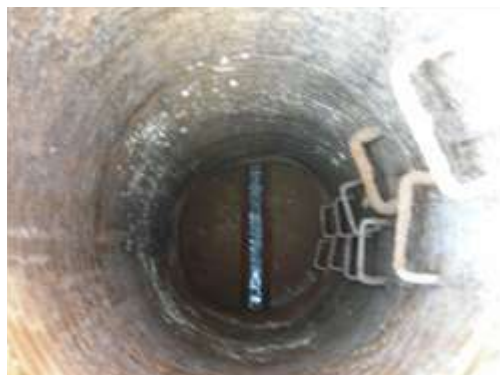
Top View

Corroded steps. Evidence of surcharge - Bench debris.

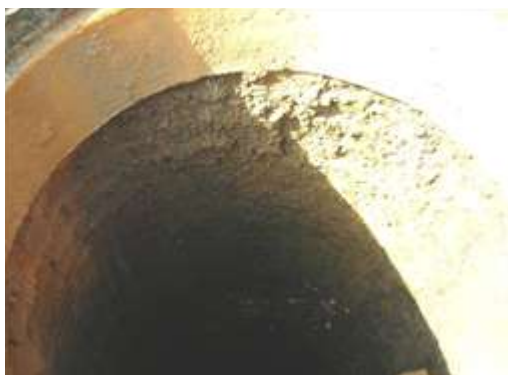
Defect

Frame leaks. Adjustment infiltration - other side.

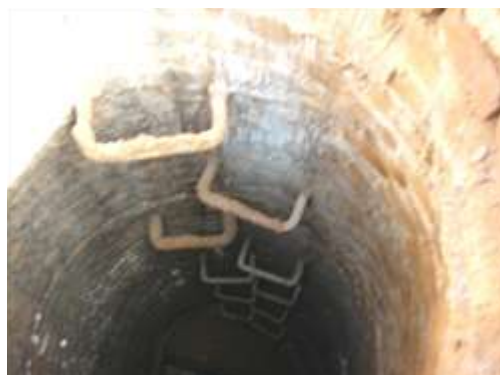
Defect

Corroded steps. Corbel and Barrel infiltration.

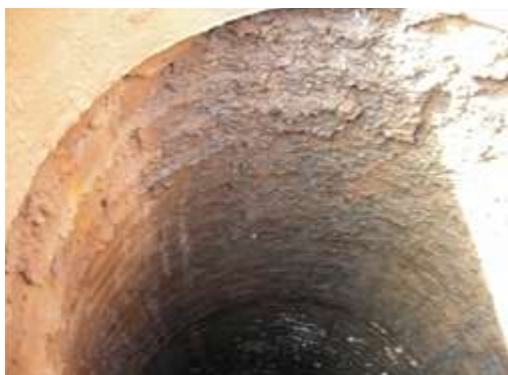
Defect

Frame leaks. Adjustment infiltration.

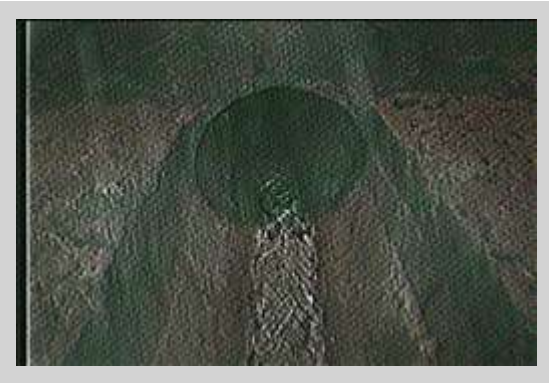
10 in. Circular Gravity Sewer Pipe Out @ 12 O'Clock

Infiltration: **Evidence** Pipe Seal Cond: **Cracked**
